# STATUS, TRENDS, AND FUTURE OF EELGRASS IN CALIFORNIA

California Marine Affairs & Navigation Conference (CMANC)  
San Pedro, California

January 18, 2018  
Keith Merkel  
*Merkel & Associates, Inc.*

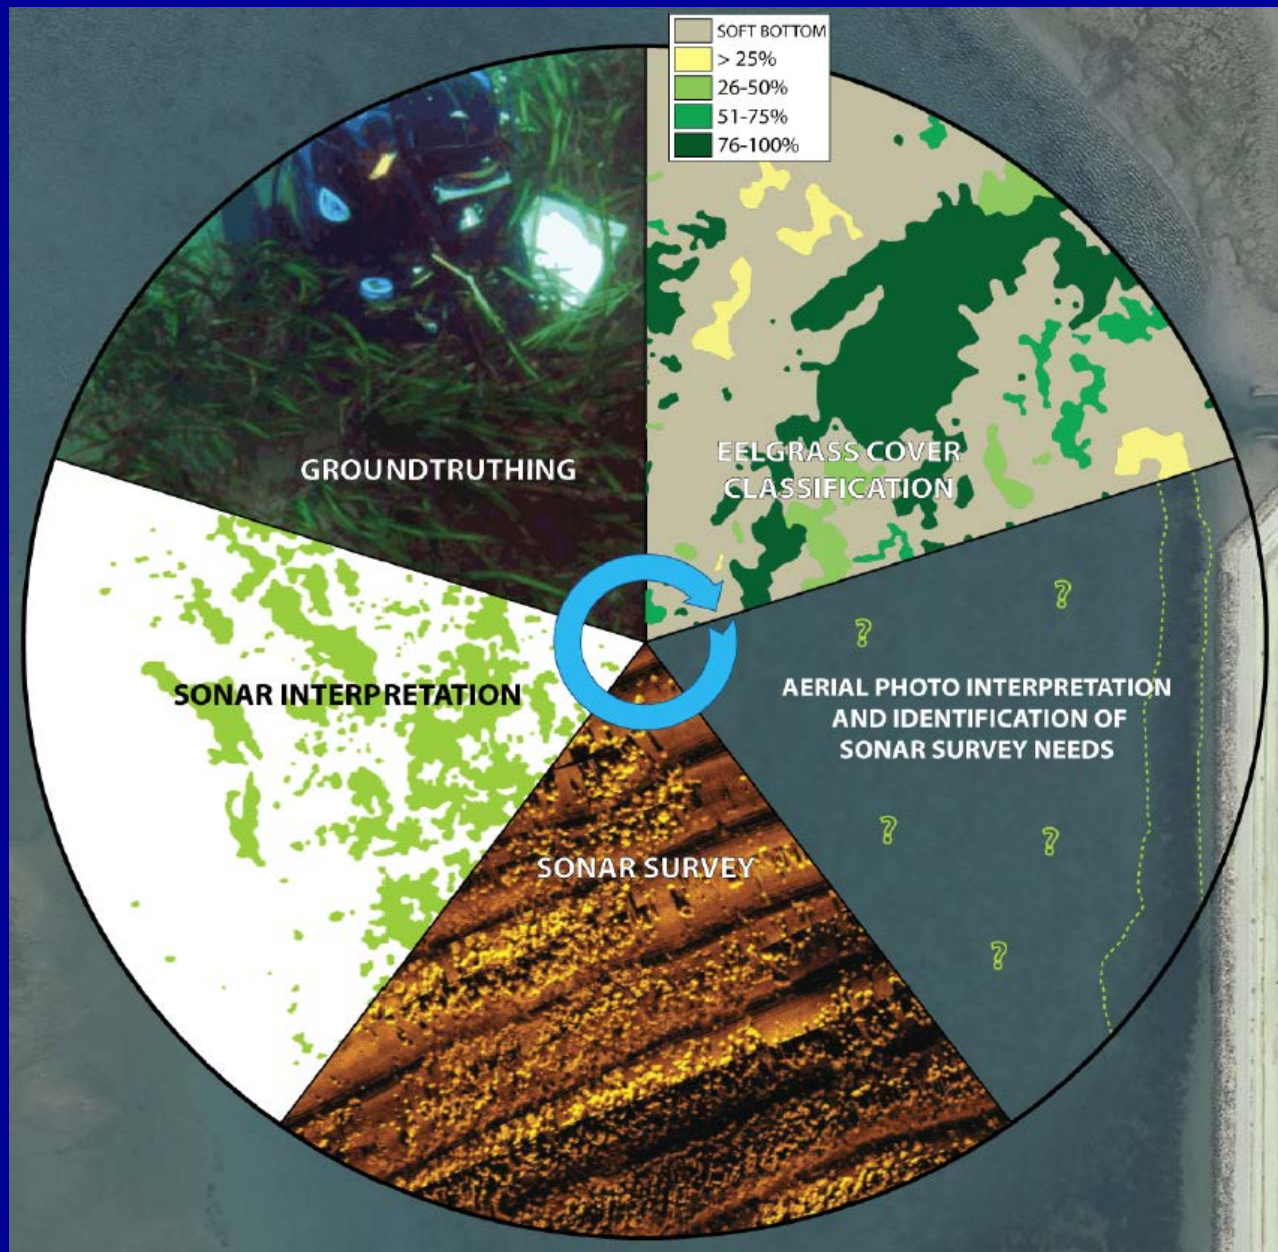
# Diagrammatic Survey and Mapping for Regional Inventories

- Multiple surveys and data sources contribute to estimates of eelgrass statewide
- NMFS/CDFW, and others working to fill data gaps
- Approximately 80% of bays and estuaries have been surveyed and eelgrass mapped over 90% of the bays and estuaries by area having been examined
- Less than 20% of the open coastal habitat area suitable to support eelgrass has been examined
- Regional eelgrass inventory survey and mapping differs from project level surveys and mapping

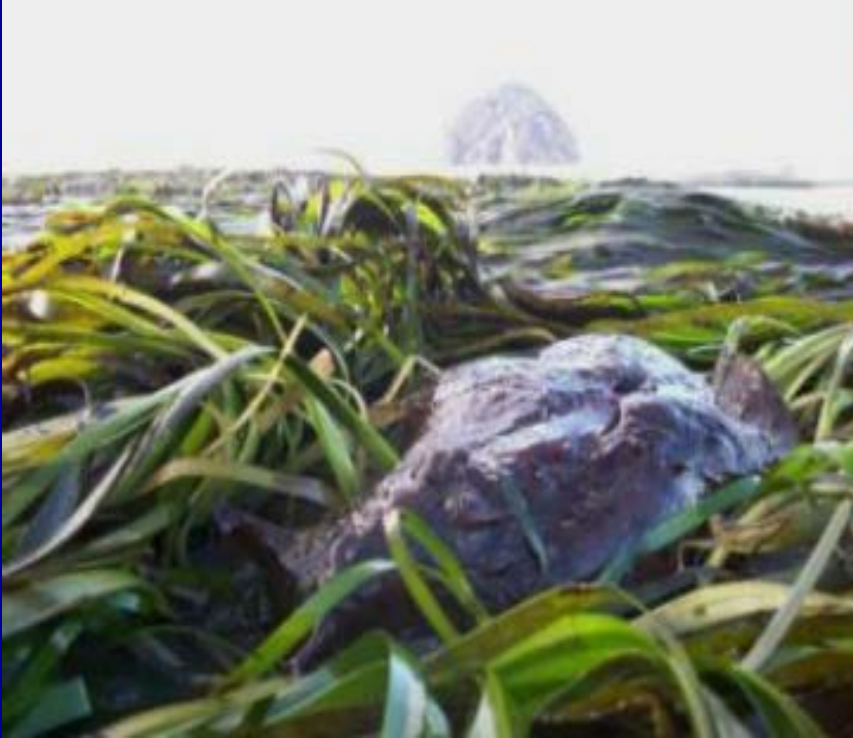
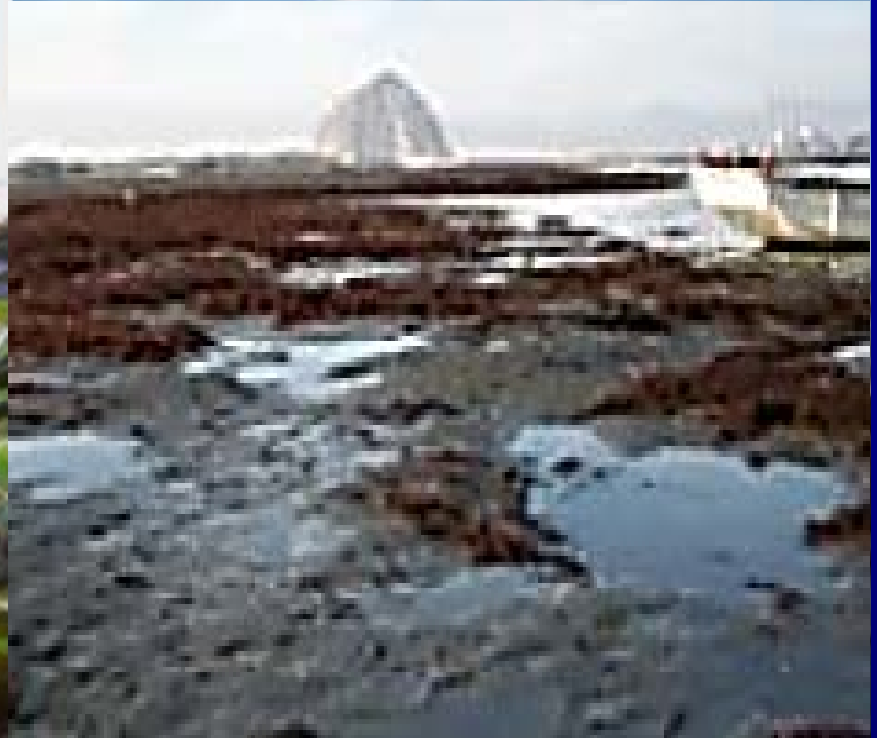
# Changes in Morro Bay Eelgrass Beds

**2009**

**2010**

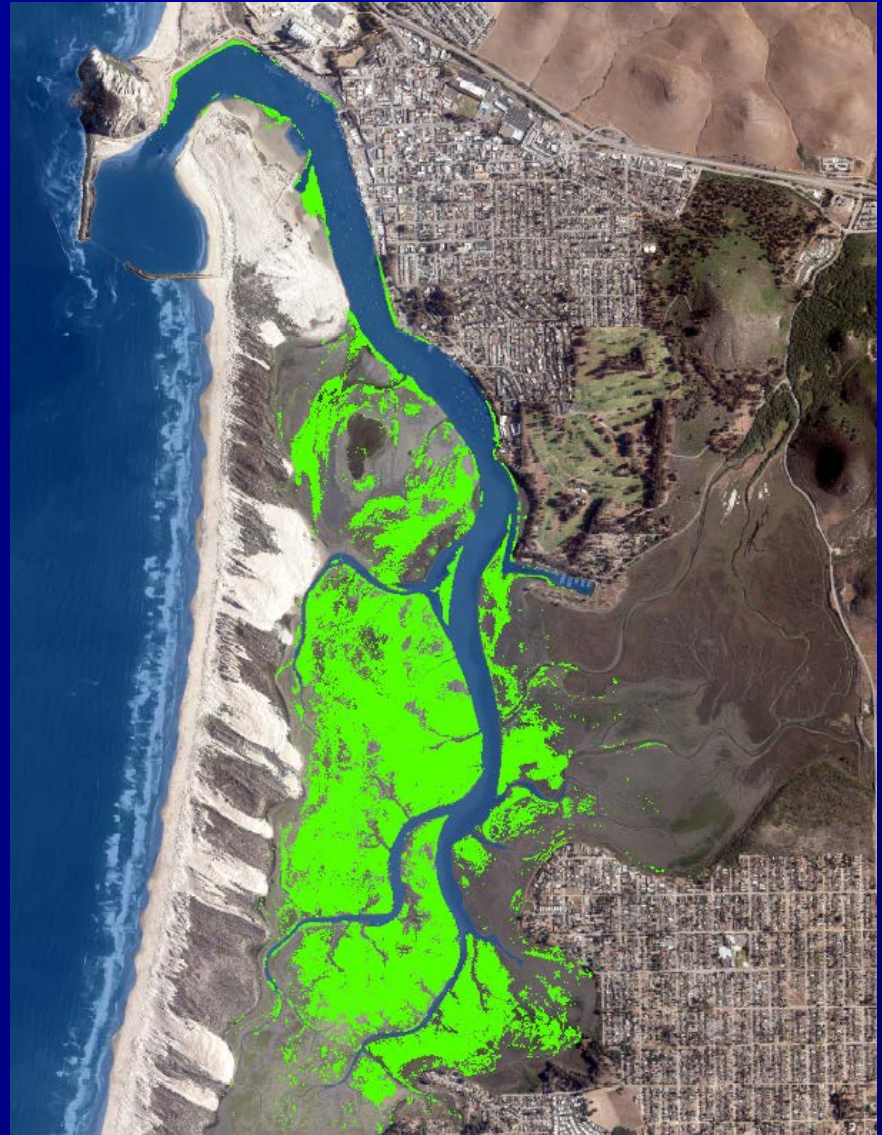
# 2007 – Morro Bay Eelgrass Distribution

- 344 acres

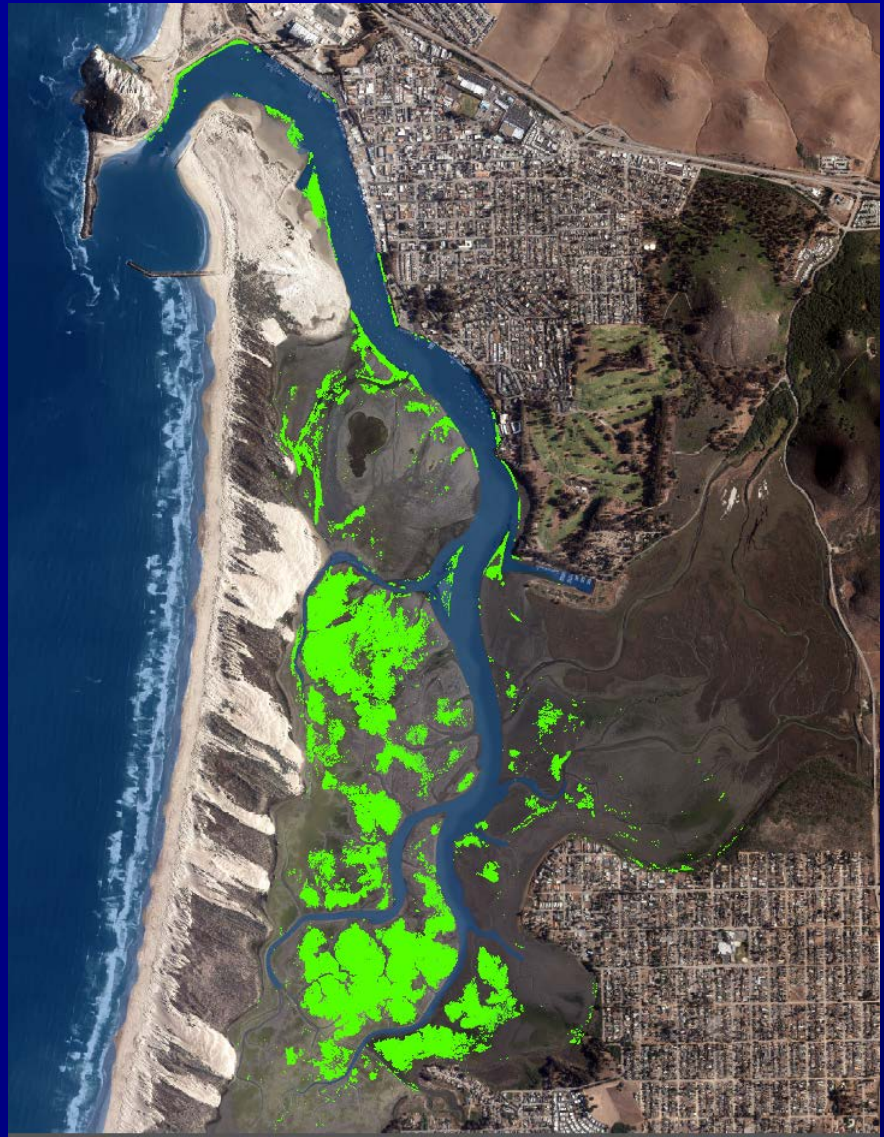
# 2010 – Morro Bay Eelgrass Distribution

- 179 acres

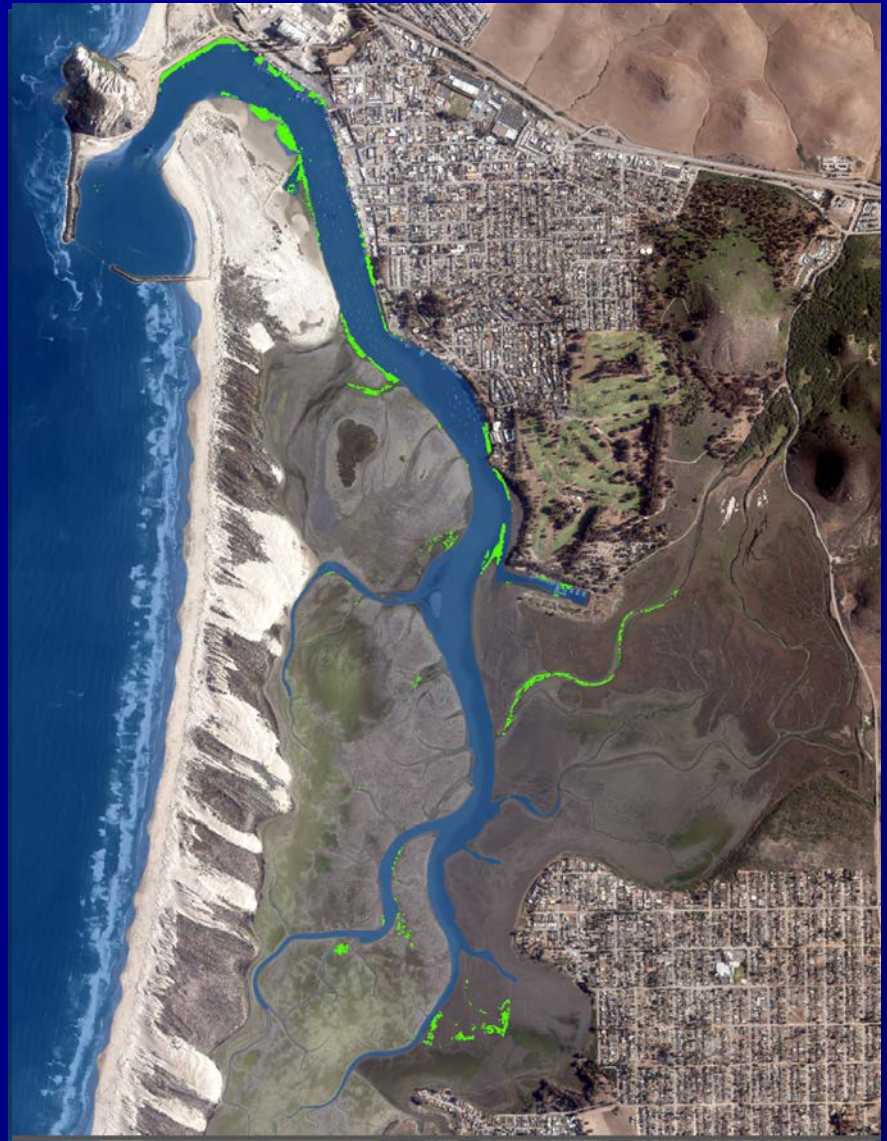
# 2013 – Morro Bay Eelgrass Distribution

- 17 acres
